# Tunnel Hill Vineyard

## P&D Monitoring Report 2020-21

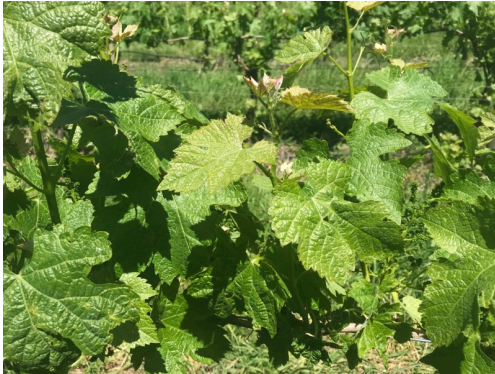
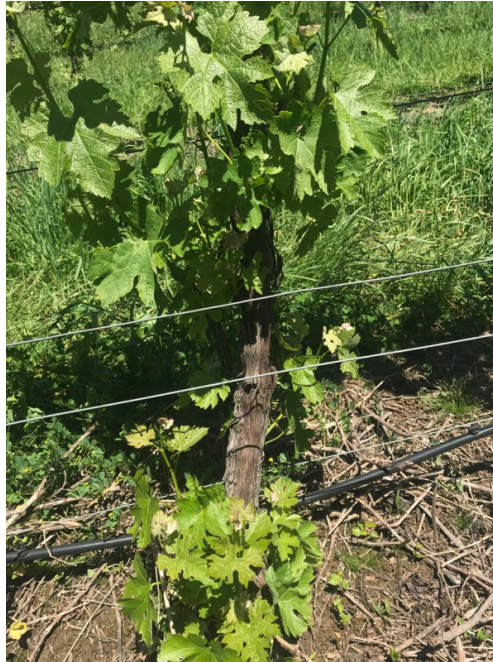
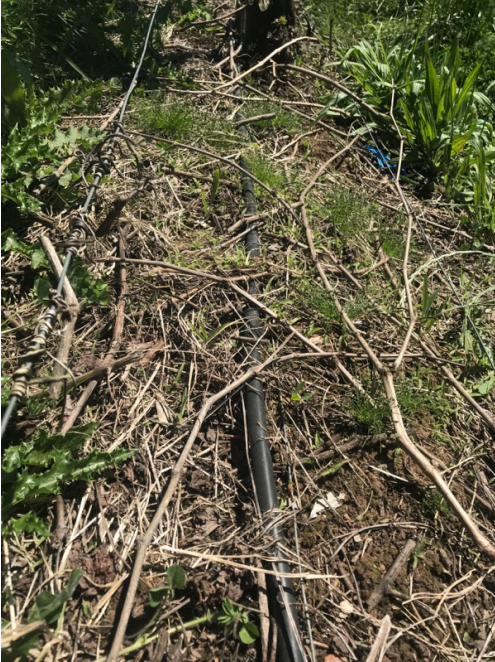
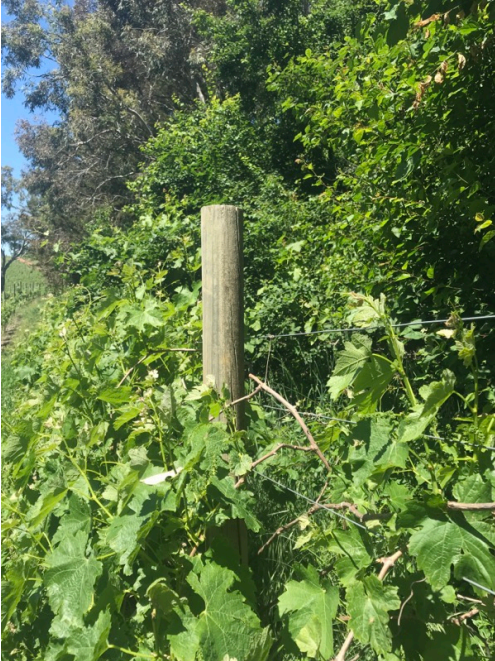
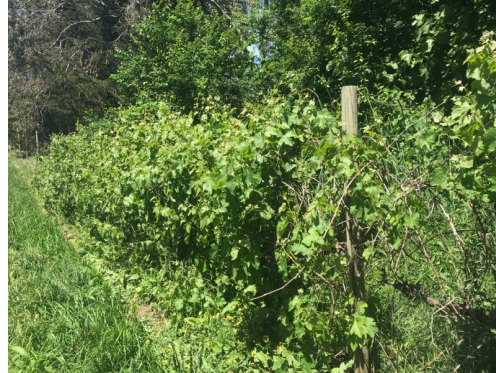
<b>Frost damage</b>	<b>Eutypa</b>	Foliage wires have been repaired
Nil	0	<b>General Block Condition</b>
<b>Cold damage</b>	<b>Nutrient Deficiency / Toxicity</b>	Two rows on the westerly side need attention as trees have overgrown rows and cannot be accessed ,several vines are feral
Nil	No ,vines look healthy	
<b>Notes / Other</b>

Water shoots will need removing from the crown down

and are a haven for disease to develop

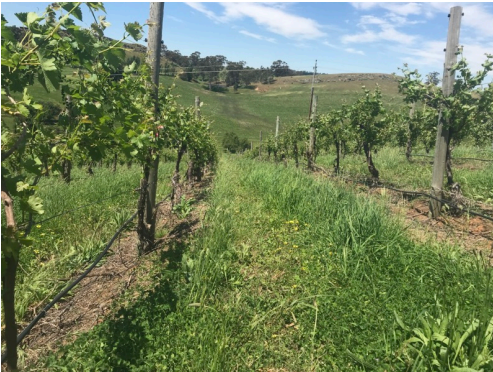
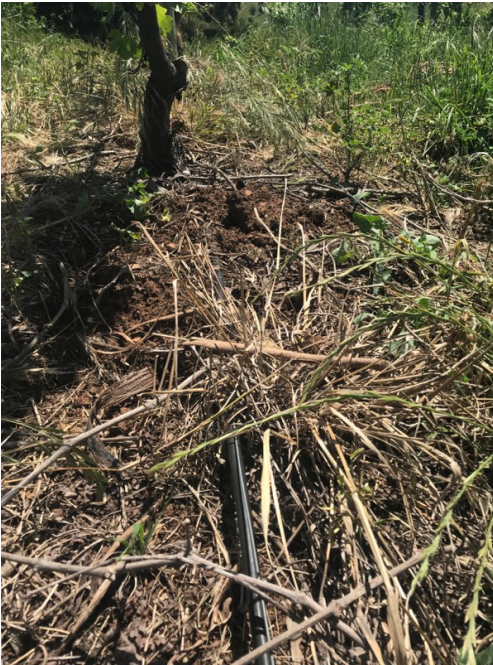
Cab sav looks good, Dripline needs attention . It needs to be strained and off the ground so ants don't block the emitters and we get a even watering pattern undervine

As this is a Treasury (Penfolds)block . The irrigation needs attention if we are to grow a grade fruit.

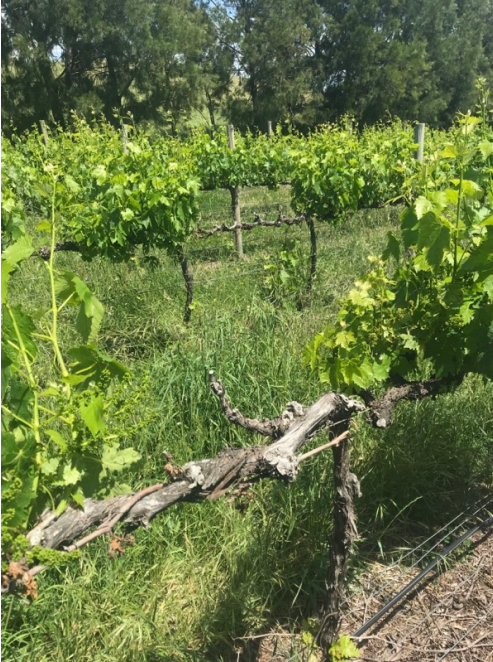
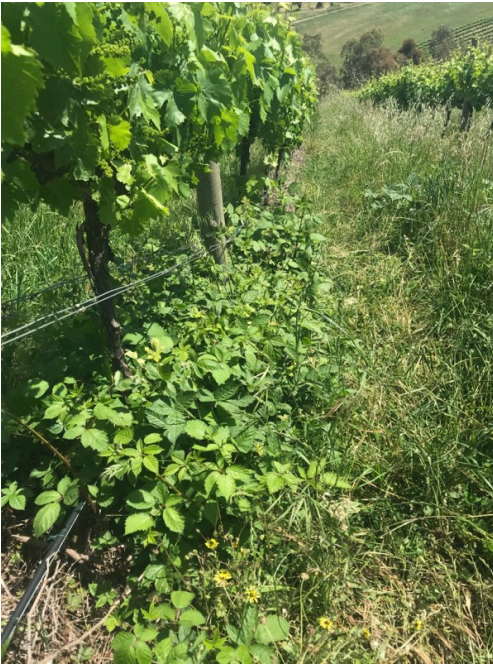
<b>EL Stage</b>	0	<b>Irrigation System (Leaks, blocked emitters etc.)</b>
16	<b>Downy Mildew (old infection)</b>	Drip lines need straining to get them off the ground
<b>Tip Growth</b>	0	<b>Weed Growth (vine rows)</b>
Fresh	<b>Diaporthe</b>	Have commenced undervine spraying
<b>Canopy Height (av. - cm)</b>	0	<b>Weed Growth (mid rows)</b>
70	<b>Phomopsis</b>	Yes
<b>Canopy Width (av. - cm)</b>	0	<b>Sward Length (rows / headlands)</b>
40	<b>Botrytis (leaf)</b>	800 mm
<b>Canopy Density (thinning requirements)</b>	0	<b><u>Trellis, General Vineyard</u></b>
No	<b>Botrytis (bunch)</b>	<b>Broken Posts (intermediate, strainers)</b>
<b>Crown Density (thinning requirements)</b>	0	Broken posts removed but not replaced.
No	<b>Mites</b>	<b>Broken Wires</b>
<b>Leaf Colour</b>	0	Foliage wire have been repaired
Medium green	<b>Snails</b>	<b>General Block Condition</b>
<b>Canopy Lifting</b>	<1	There is intermittent eutypa throughout the block .

Lift wires will be needed	<b>Scale (adults)</b>	Blackberry bushes undervine need to be removed/ sprayed out.
<b>Leaf Loss (shading or stress)</b>	<1	
No	<b>Scale (eggs)</b>	
<b>Watershoot Growth</b>	0	
Yes	<b>Scale (crawlers)</b>	
<b>Fruit / Inflorescence Density, Overcropping</b>	0	
Good	<b>LBAM (webbing / moths / eggs / caterpillars)</b>	
<b>Inflorescence / Bunch Condition &amp; Size</b>	None found	
Large healthy inflorescence	<b>Weevils</b>	
<b>Frost damage</b>	0	
No	<b>Eutypa</b>	
<b>Cold damage</b>	1	
No	<b>Nutrient Deficiency / Toxicity</b>	
	Flag shoots visible from vines with eutypa	
	<b>Beneficials</b>	
	Yes	
	<b>Pest &amp; Disease Notes / Other</b>	
	Healthy canopy apart from the eutypa
