P&D Monitoring Report Hanna Ridge Vineyard 2022-23

Block A Pinot Gris

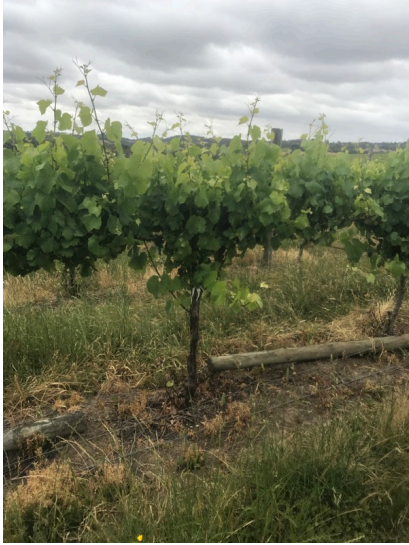
Moderate vigour (image 1)-
picking up with some warmer
weather.

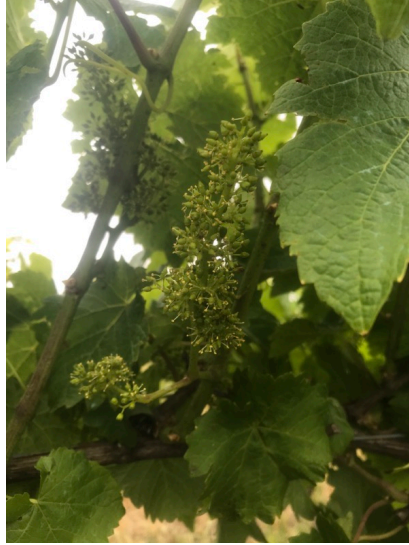
Medium size (image 2), medium
to high density.

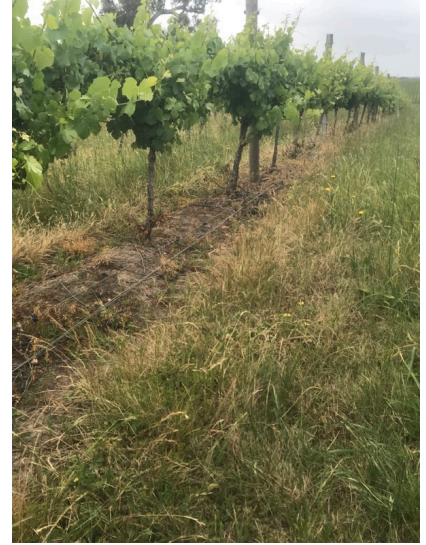
Sprayed- mostly dying (image 3)

Sprayed- dying (image 3)

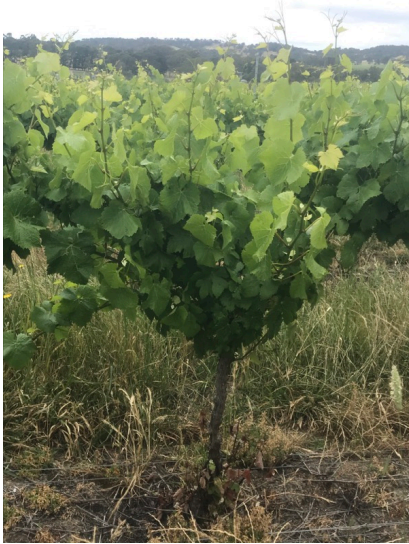
Some dense crowns (image 4)

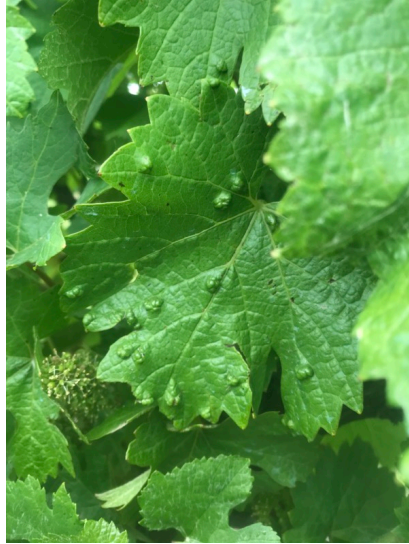
Some Blister Mite (image 5)

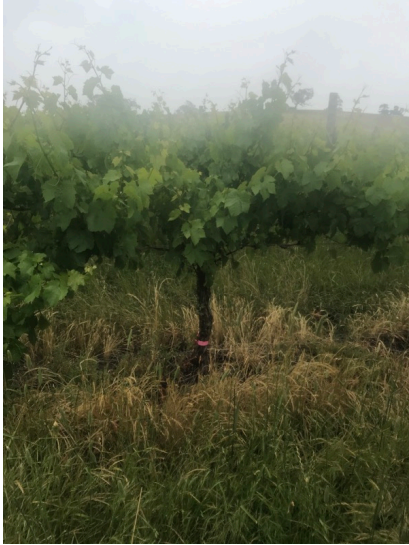
Good vigour (image 1)

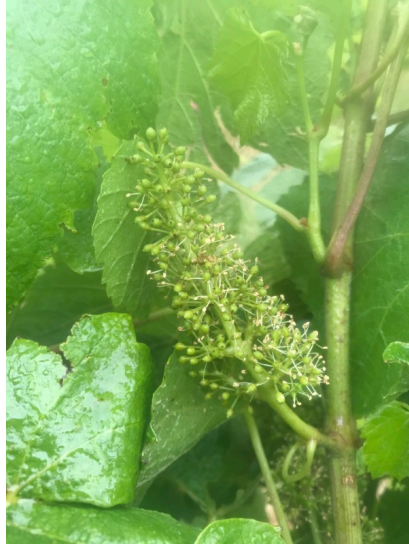
Medium size (image 2), medium density.

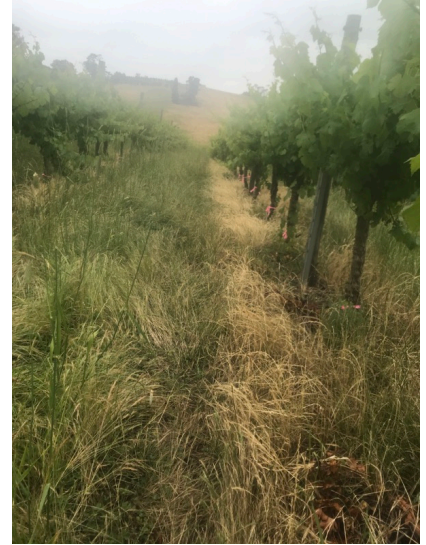
Flagged for rejuvenation (image 3)

Sprayed- dying (image 3)

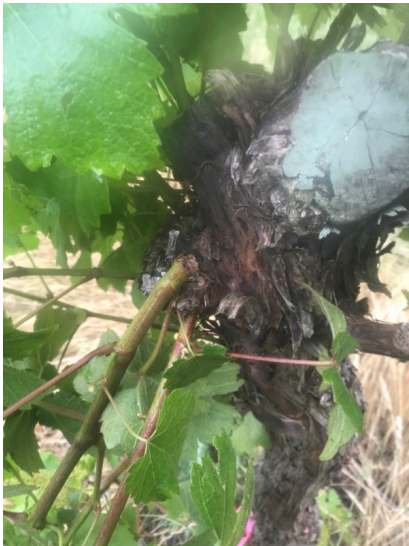
Some wind damage, broken shoots (image 4)- not a lot.

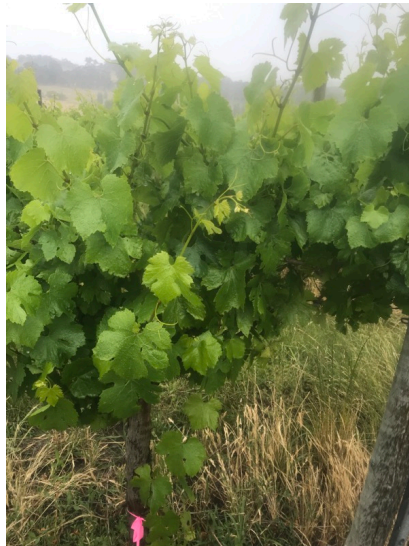
Some dense crowns (image 5)

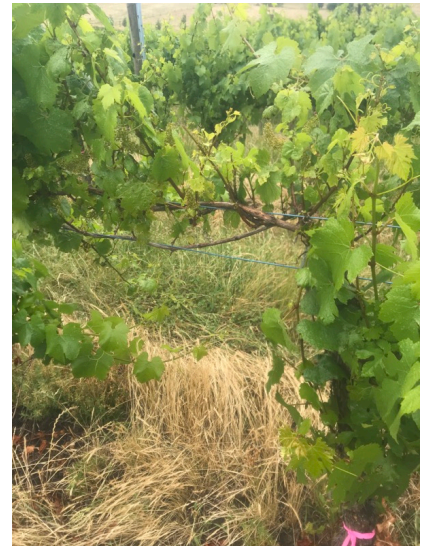
Generally not showing up on the canes, some patches of low vigour (image 6).

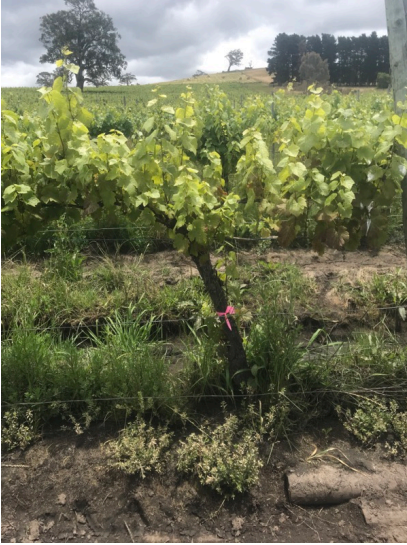
Some low vigour, deficiency symptoms lower waterlogged swampy section (image 7).

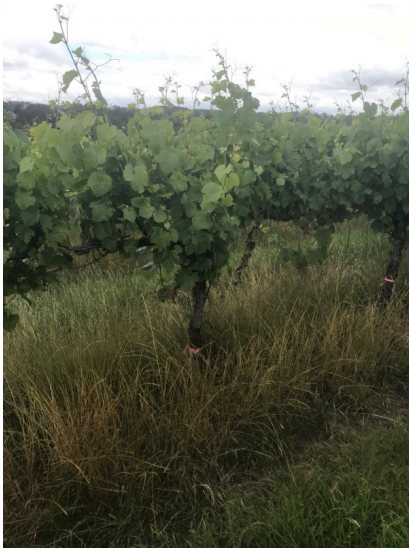
Generally good vigour (image 1)

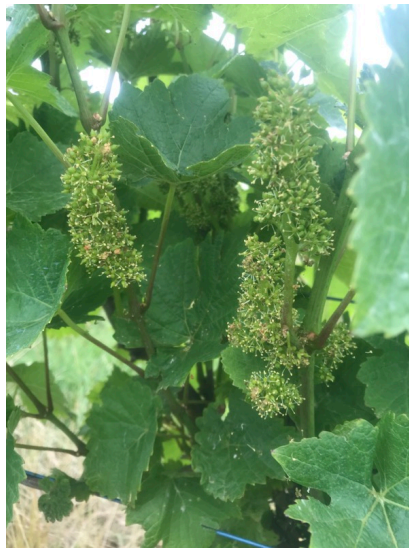
Medium size (image 2), medium to high density.

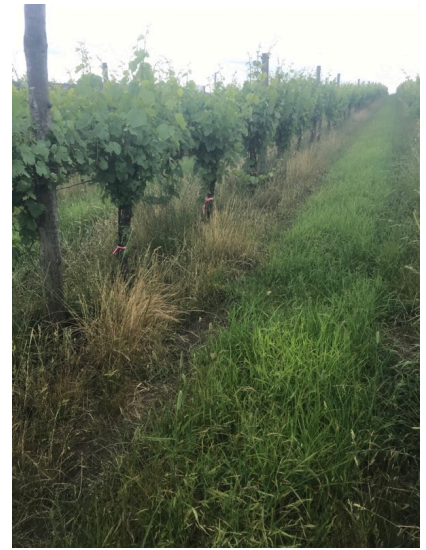
Sprayed- mostly dying (image 3)

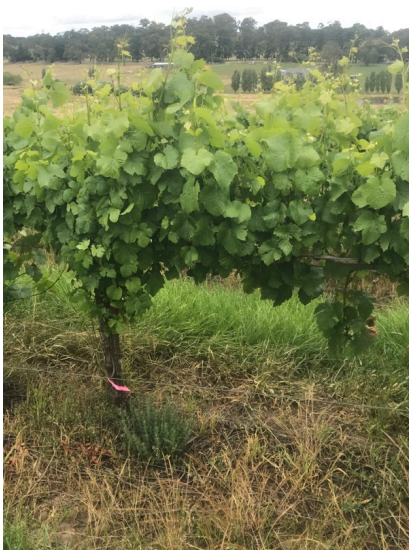
Some dense canopy and crowns (image 4)

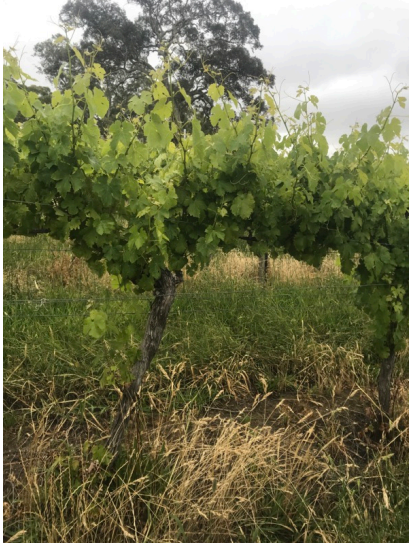
Moderate vigour (image 1)

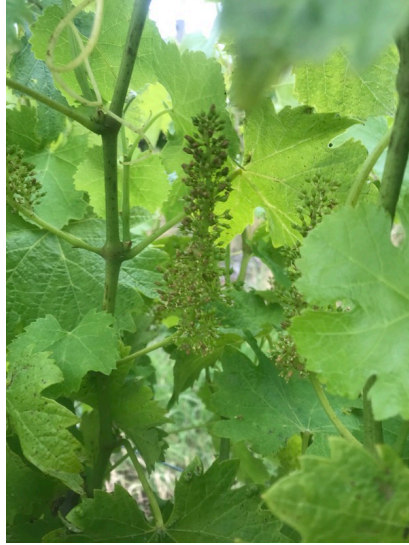
Small size (image 2), medium density.

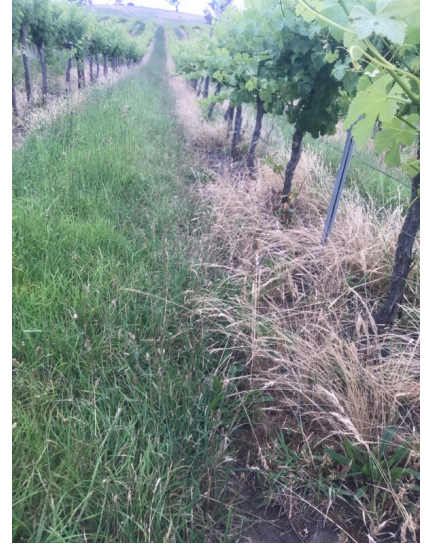
Sprayed- mostly dying (image 3)

Sprayed- dying (image 3)

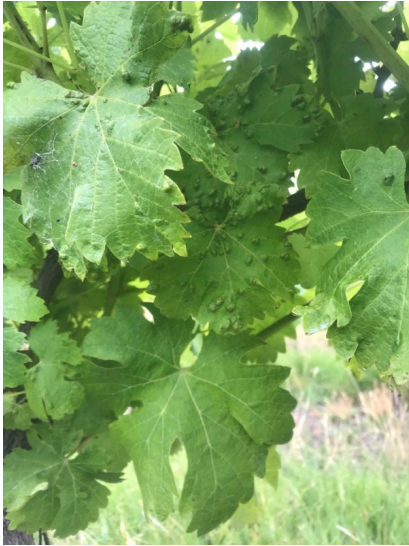
Some Blister Mite (image 4)

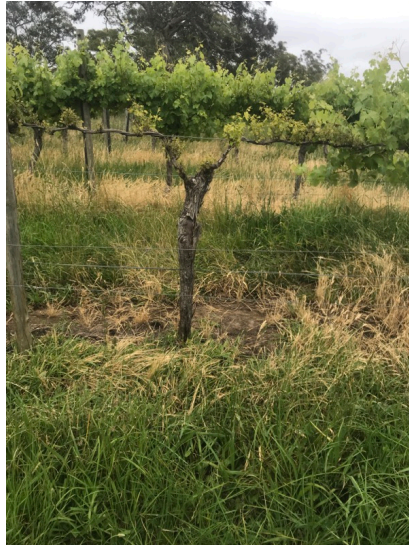
Quite a lot of Eutypa (image 5)

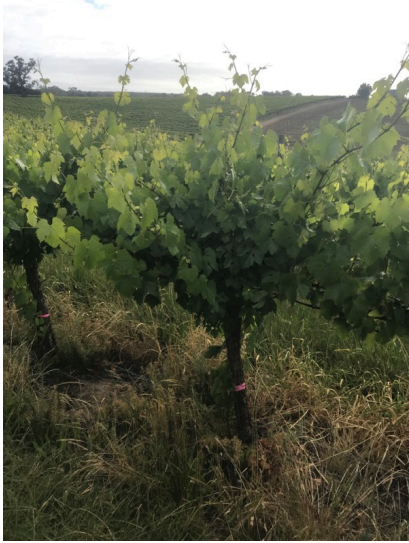
Good vigour (image 1)

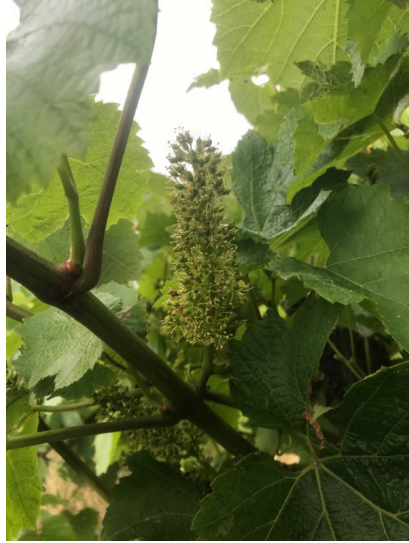
Watershoots flagged for rejuvenation (image 2)

Medium size (image 2), light to medium density- some apical dominance, gaps (image 7).

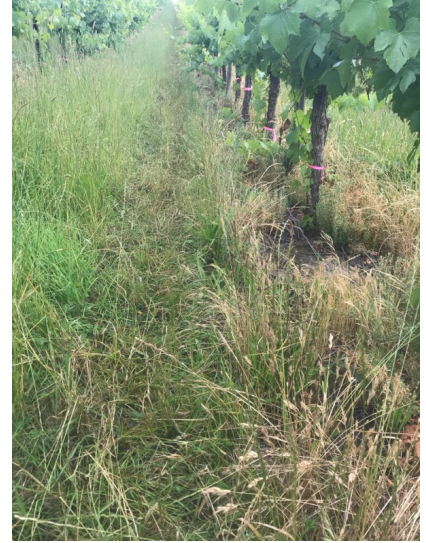
Sprayed- dying (image 3)

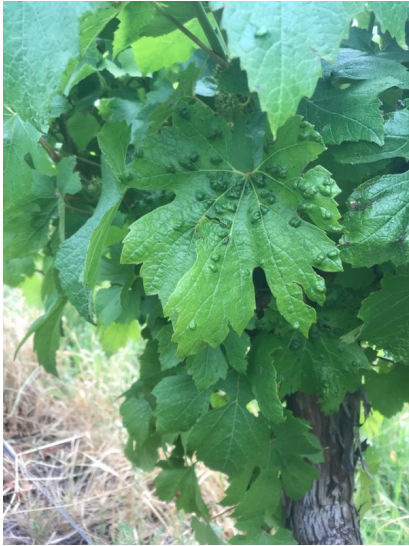
Some Blister Mite (image 4)

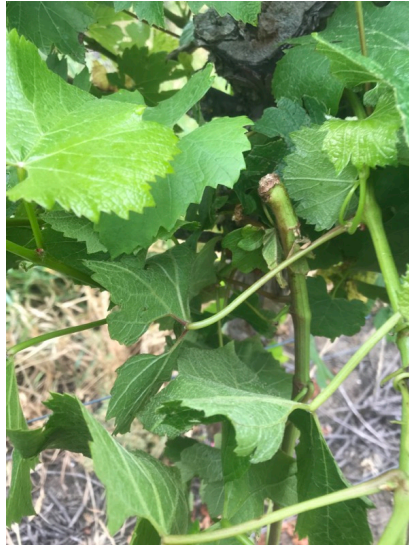
Some wind damage- broken shoots (image 5) - not a lot.

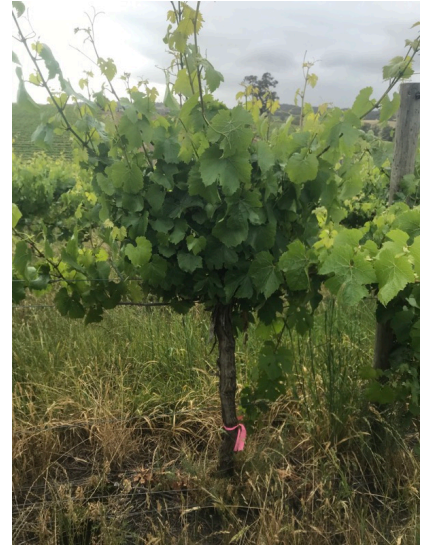
Some dense crowns (image 6)

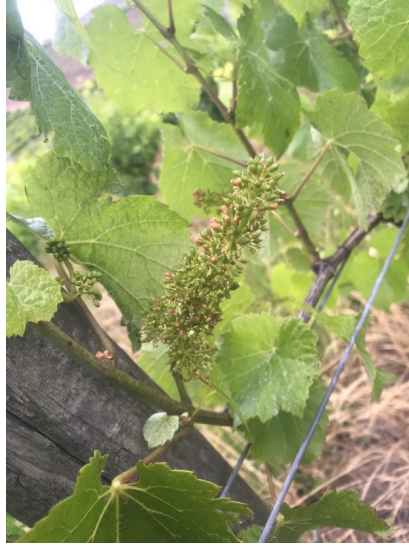
Small to medium size (image 2),
Lmedium density- some gaps (image 4)

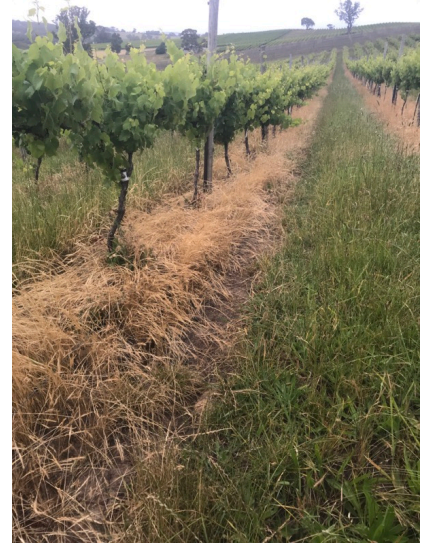
Sprayed- dying (image 3)

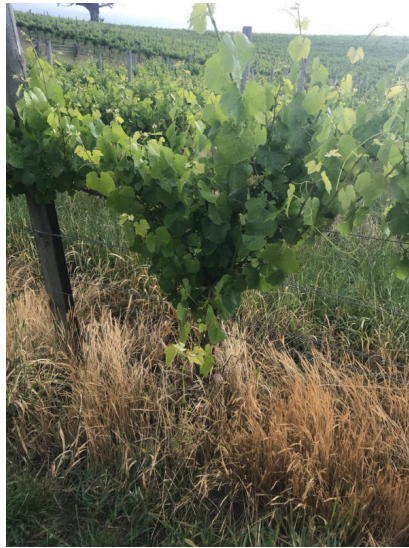
Some dense crowns (image 5).

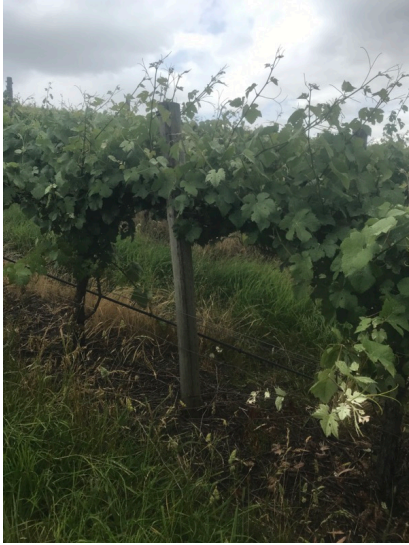
Generally good vigour (image 1)-
picking up with some warmer
weather.

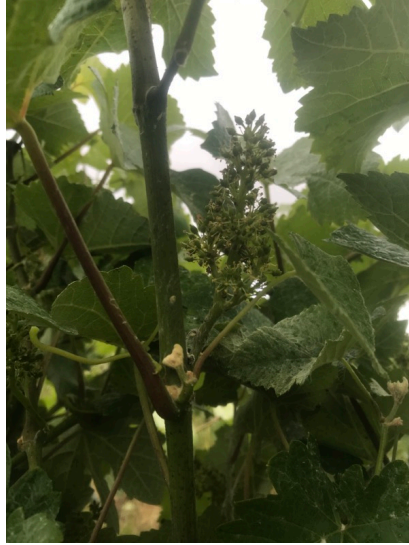
Small to medium size (image 2),
medium density

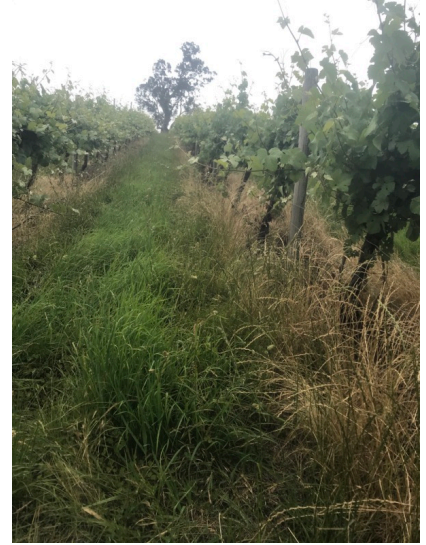
Sprayed- mostly dying (image 3)

Sprayed- dying (image 3)

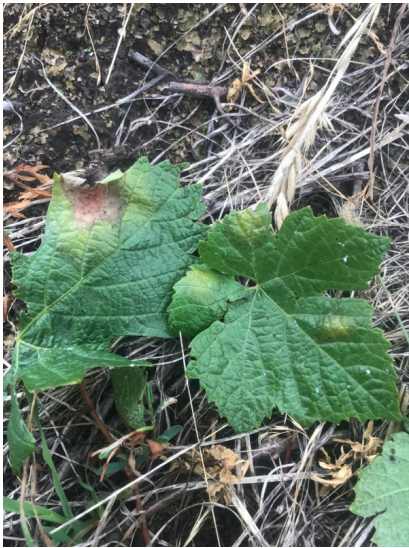
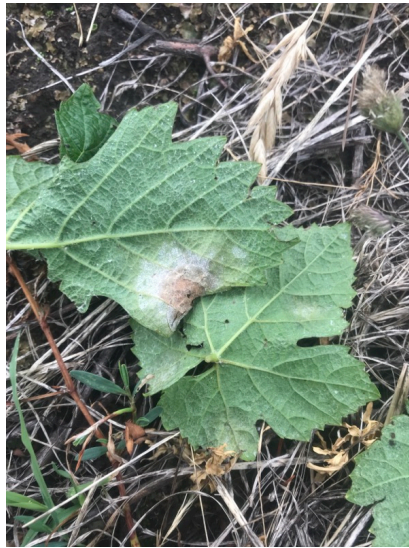
Downy Mildew (images 4 & 5) on
1 in every 20 vines.

Into flowering and vigour has picked up with some warmer weather. With wet conditions and some warm nights over the past few months there have been a number of Downy Mildew alerts and some has been found in blocks H and A, and some leaves collected for testing in some other blocks. There is some Blister Mite but won't affect vine health and yield.

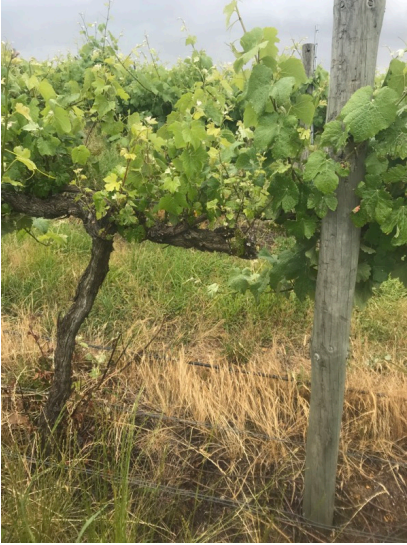
Some dense crowns (image 7)
