P&D Monitoring Report Hanna Ridge Vineyard 2022-23

Block A Pinot Gris

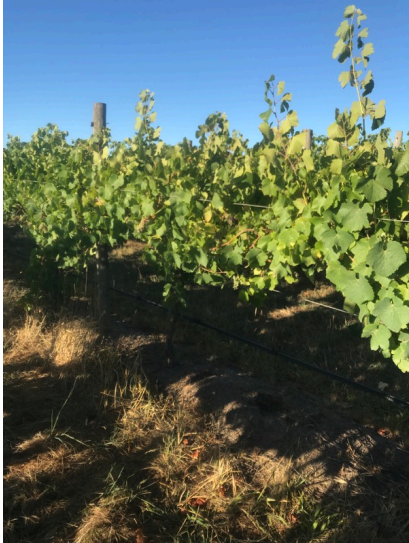
Moderate vigour (image 1)

Some dense patches (image 1)

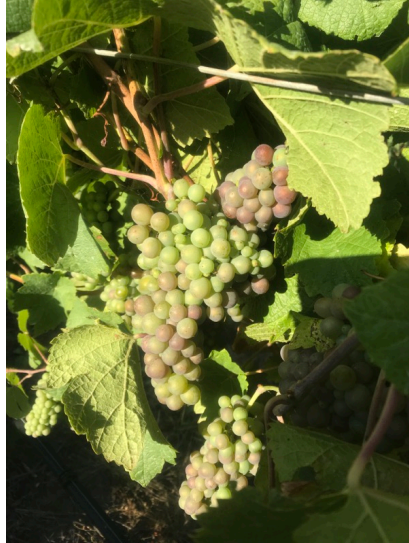
Medium size (image 2), medium to high density, some sunburn and shrivel (image 4), some secondary crop (image 6)- not a lot.

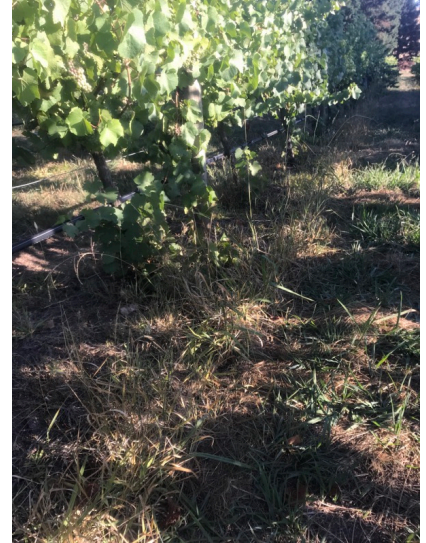
Watershoots returning (image 3)

Fairly clean (image 3)

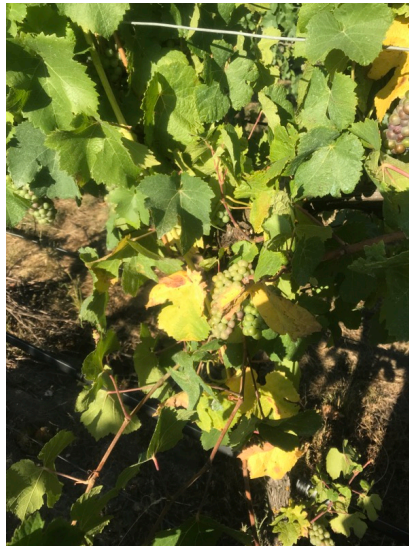
Some seasonal leaf yellowing/ loss (image 5)

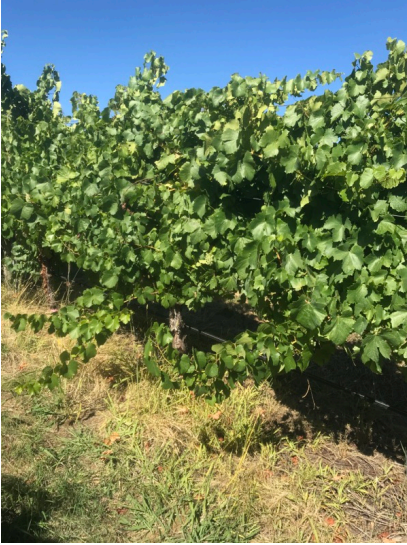
Strong (image 1)

Dense crowns (image 1)

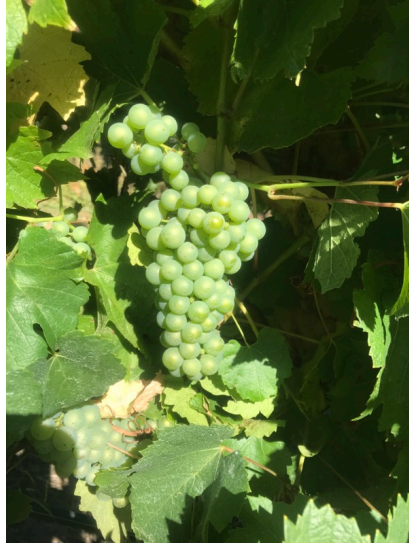
Medium size (image 2), medium density, some hen and chicken

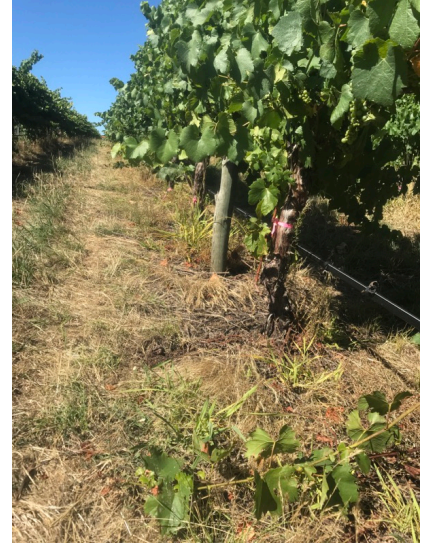
Taped for rejuvenation (image 3)

Sprayed- dying (image 3)

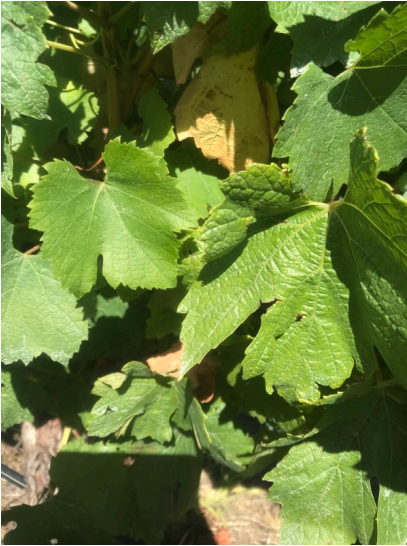
Some seasonal leaf yellowing/loss (image 4)

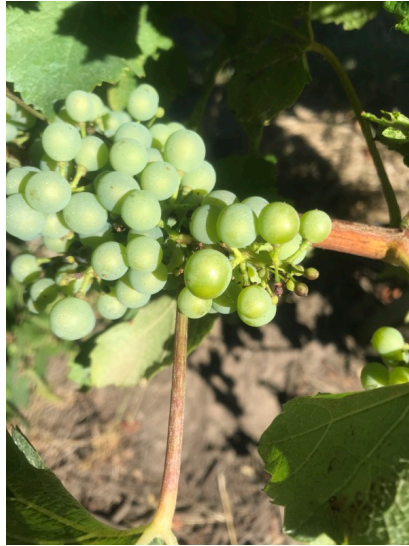
(image 5)-not a lot, some sunburn/shrivel (image 6)-not a lot.

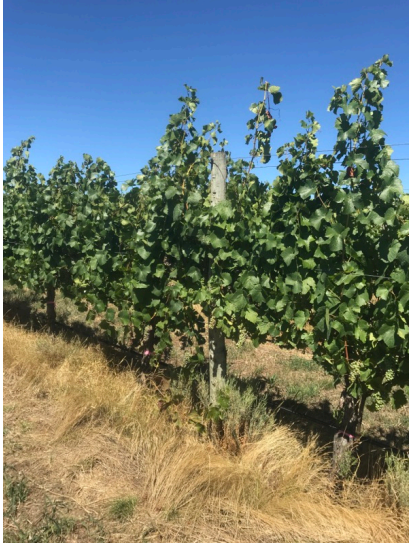
Dense crowns (image 1)

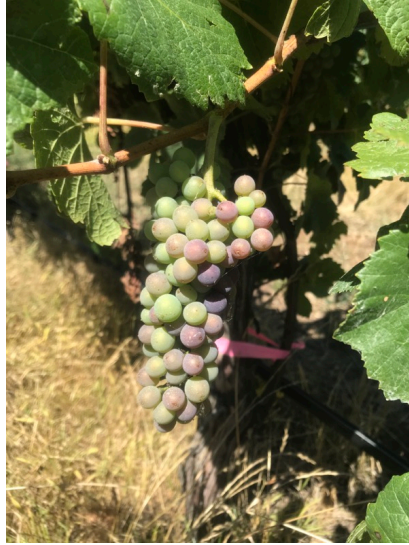
Medium size (image 2), medium to high density, some secondary crop (image 5), some hen and chicken (image 7),

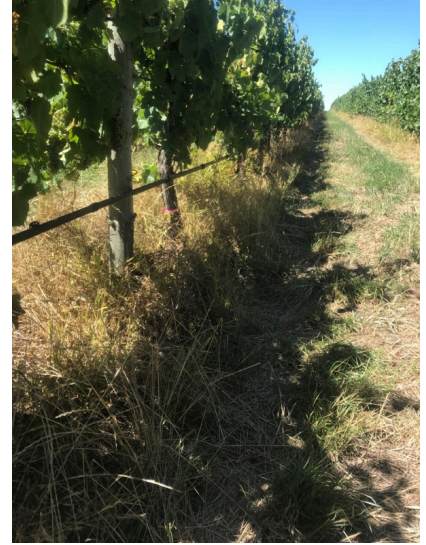
Taped for rejuvenation (image 3)

Sprayed- dying (image 3)

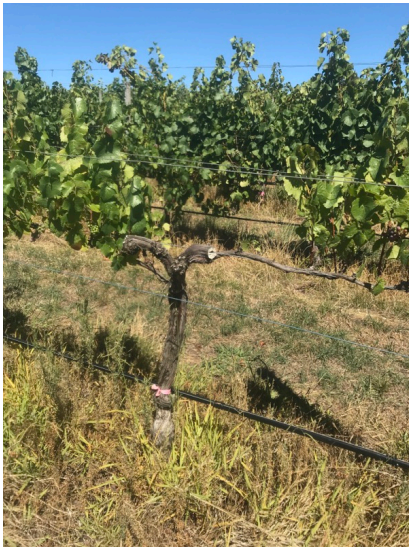
Some Eutypa (image 4), generally not showing up on the canes.

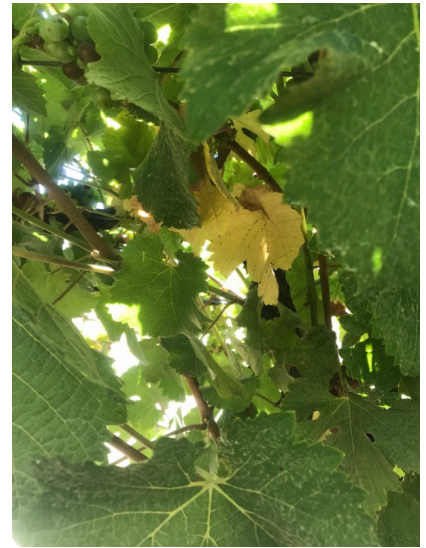
Some seasonal leaf yellowing/ loss (image 6)

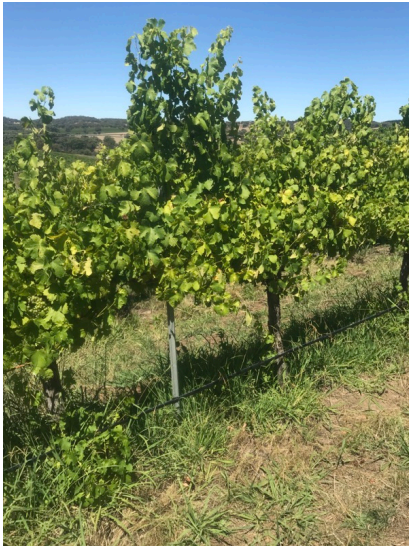
Moderate to strong in places, slowing (image 1)

Dense canopy and crowns (image 1)

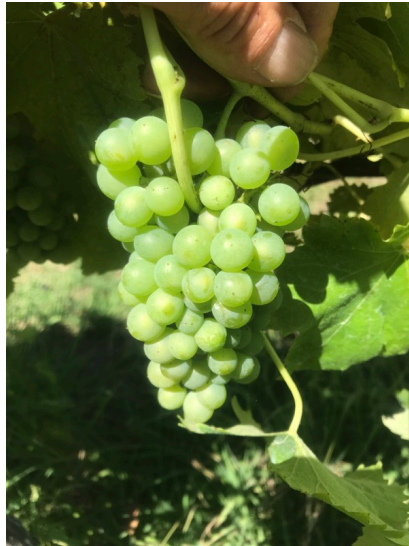
Medium size (image 2), medium density, some hen and chicken (image 5)-not a lot,

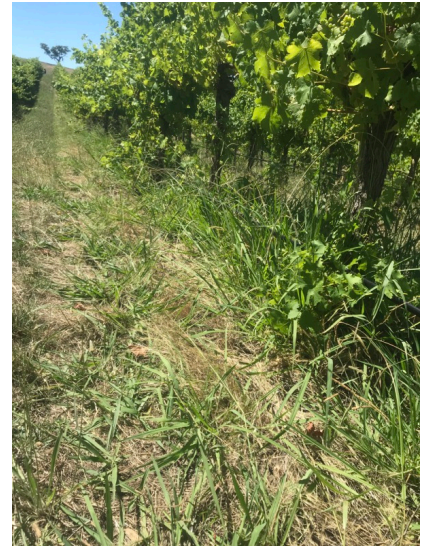
Some weeds returning (image 3)

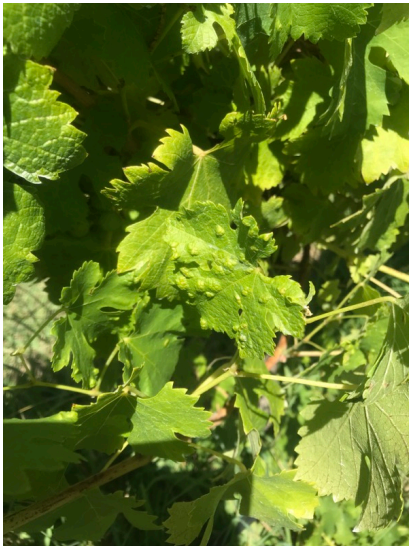
Some blister mite (image 4)

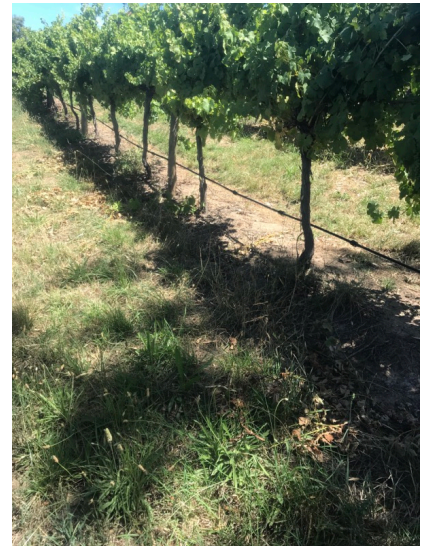
Removal in progress (image 6)

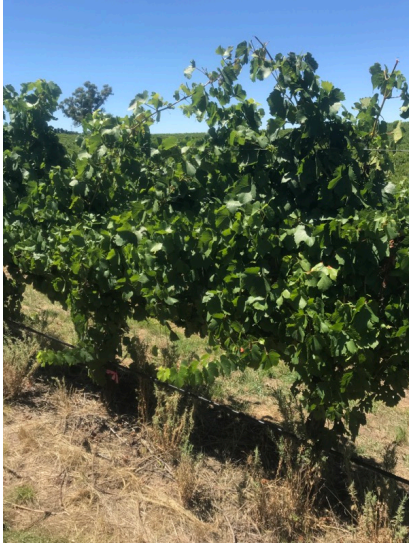
Strong- slowing (image 1)

Dense crowns (image 1)

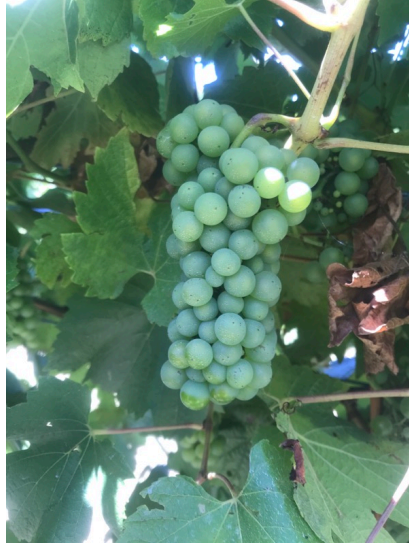
Medium size (image 2), medium density- some gaps (image 6), some sunburn/shrivel (image 4)- not a lot, some hen and chicken (not a lot), some secondary crop (image 8).

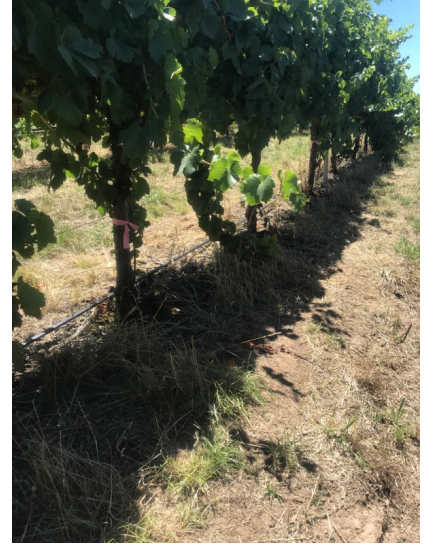
Watershoots taped for rejuvenation (image 3)

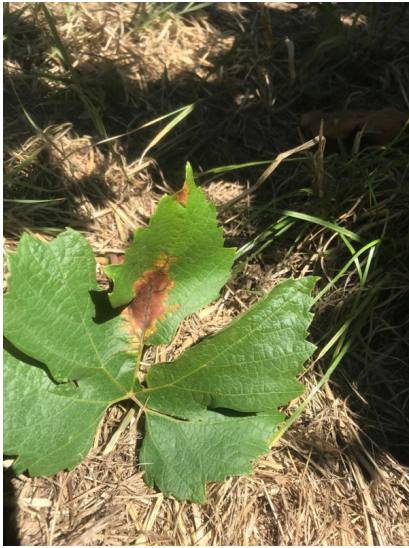
Old Downy Mildew controlled by sprays (image 7)

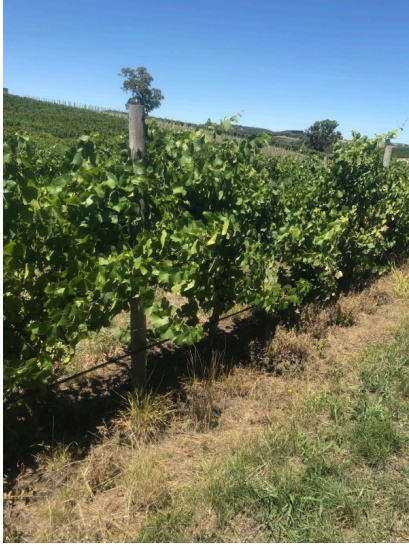
Moderate vigour (image 1)

Fairly even shoot growth (image 1)

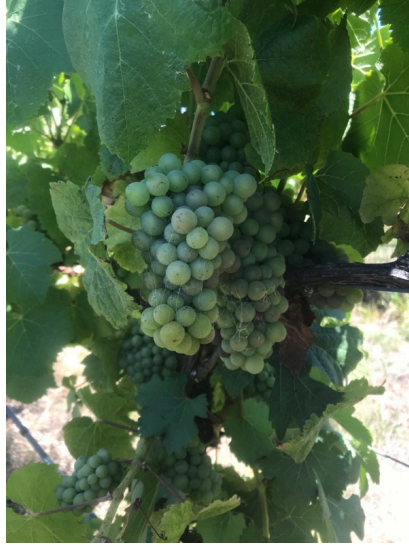
Medium size (image 2), light to medium density, some secondary crop (image 4)"

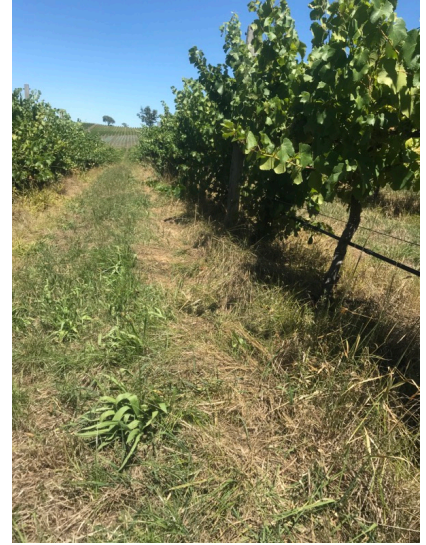
Some watershoots (image 3)

Sprayed- dying (image 3)

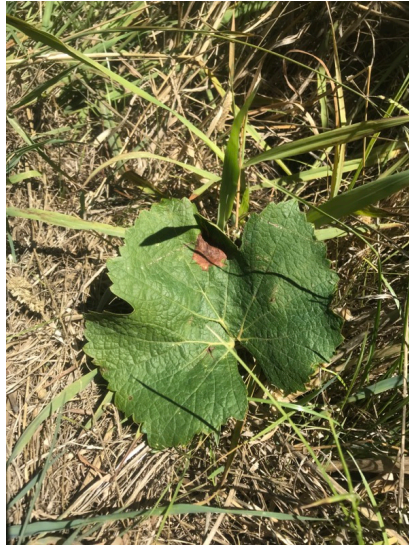
Old Downy Mildew controlled by sprays (image 5)

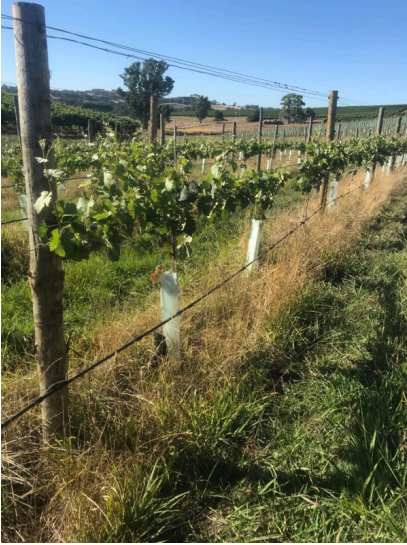
Strong (image 1)

All are up to the wire, most with arms wrapped on (images 1 & 2).

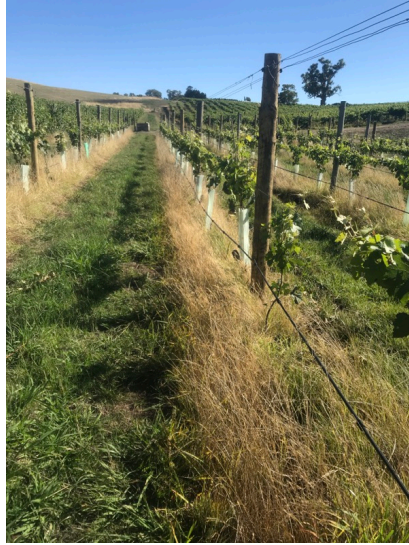
Sprayed- dying (image 2)

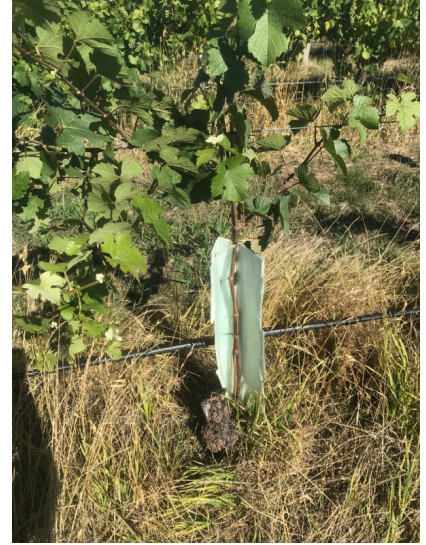
Recently trained (image 3)

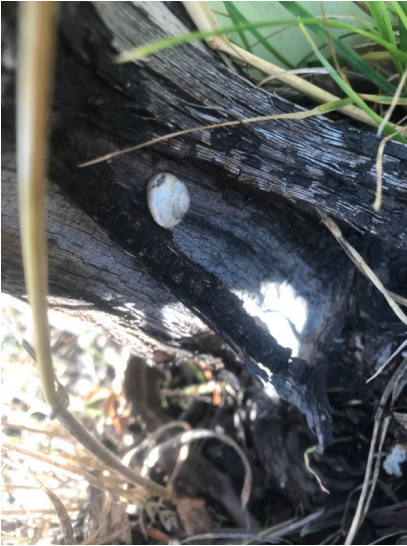
Some Italian snails (image 4)

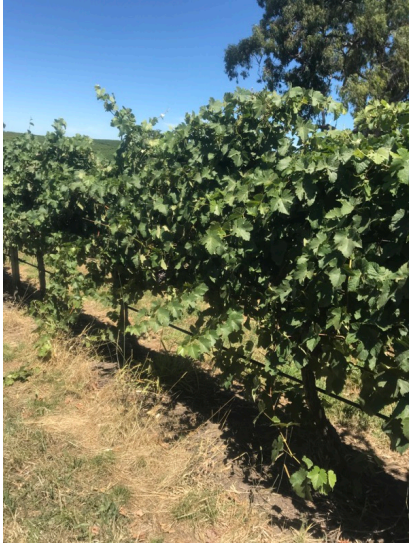
Strong- slowing (image 1)

Dense canopy and crowns (image 1)

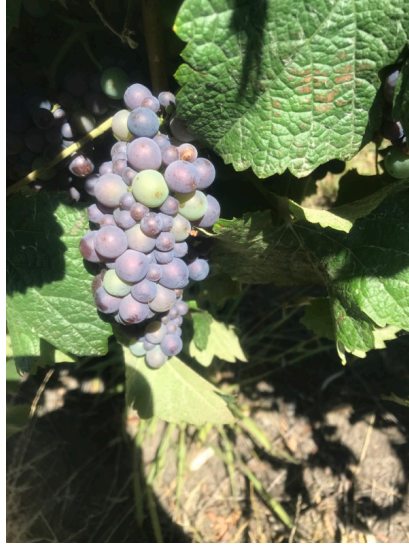
Medium size (image 2), medium to high density, some secondary crop (image 4), some sunburn/ shrivel (image 6)- not much.

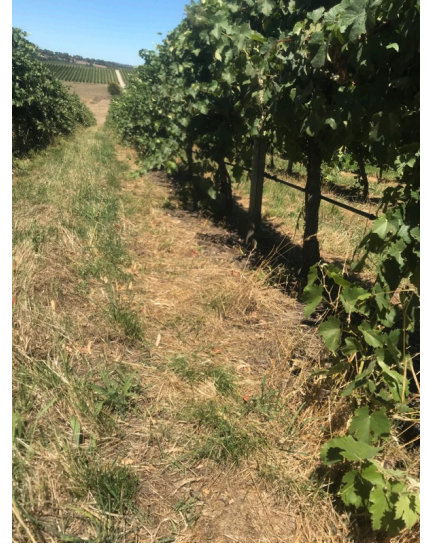
Watershoots returning (image 3)

Sprayed fairly clean (image 3)

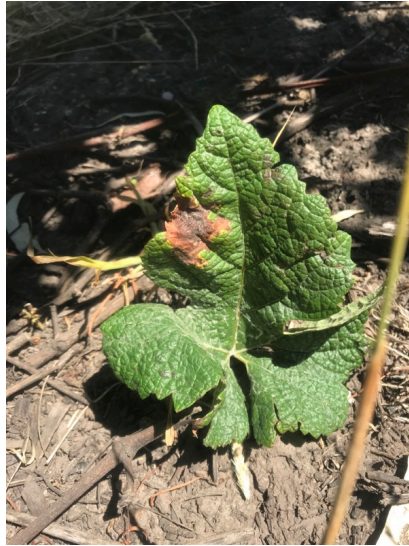
Old Downy Mildew controlled by sprays (image 5)

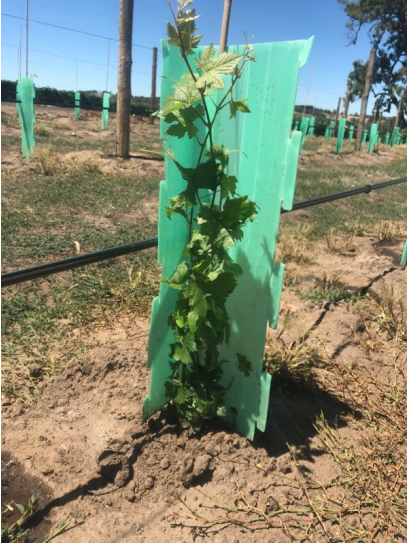
Most are growing (image 1)

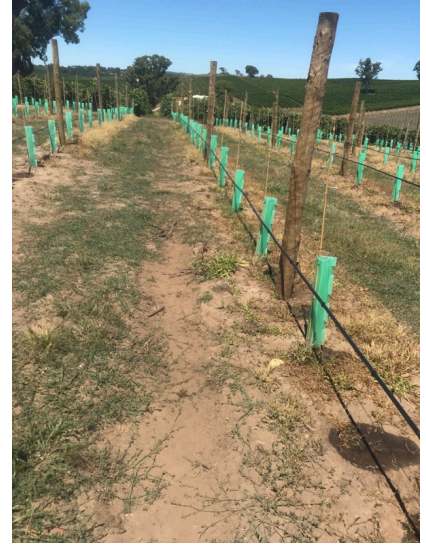
Sprayed- clean (image 3)

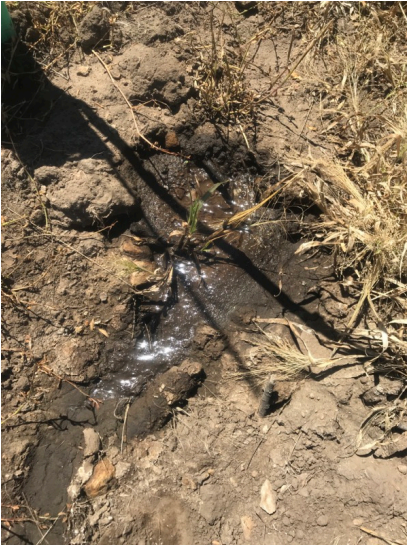
Good (image 4)

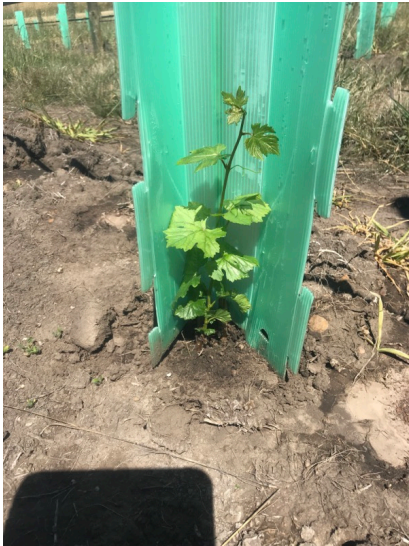
Most are growing (image 1)

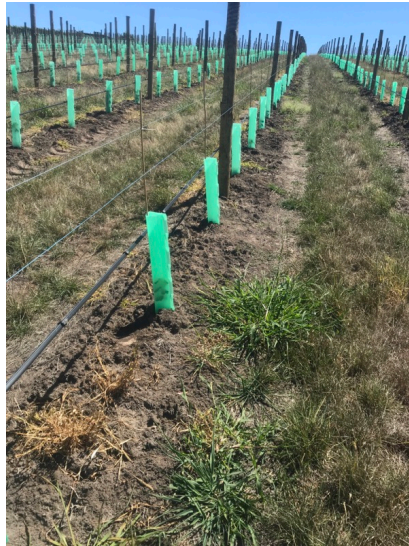
Sprayed- clean (image 2)

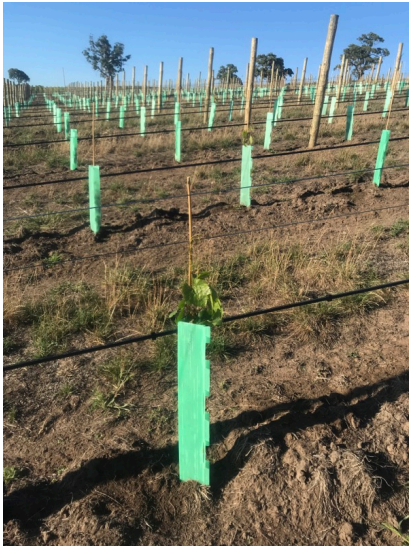
Strong- many out of vineguards
(image 1)

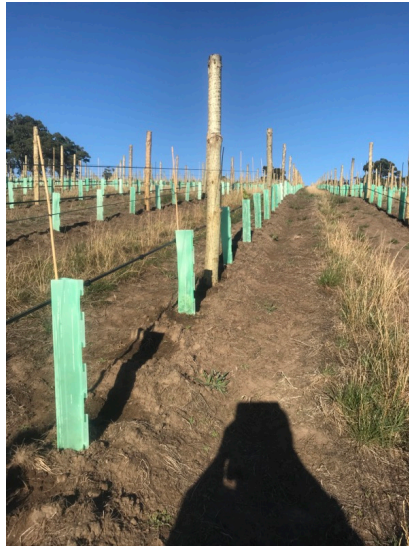
Mostly clean (image 2)

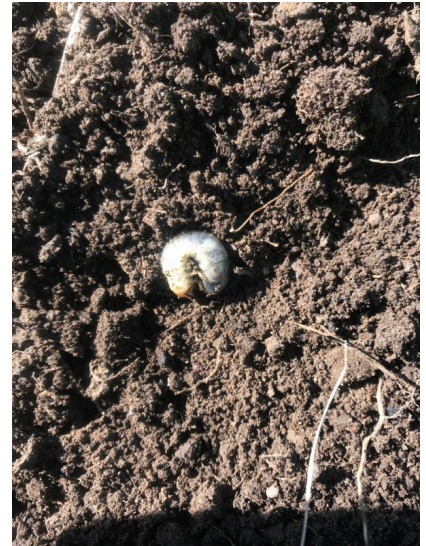
Not sighted, some black beetle
larvae (image 3)

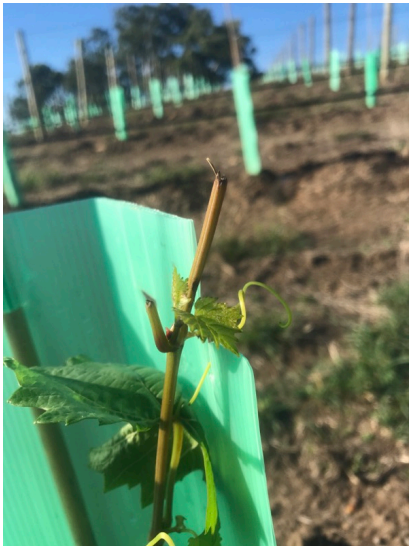
Some kangaroo damage (image
4).

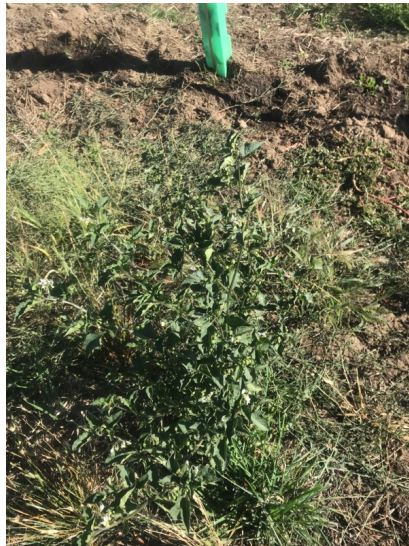
Some broadleaf including
Nightshade (image 5)

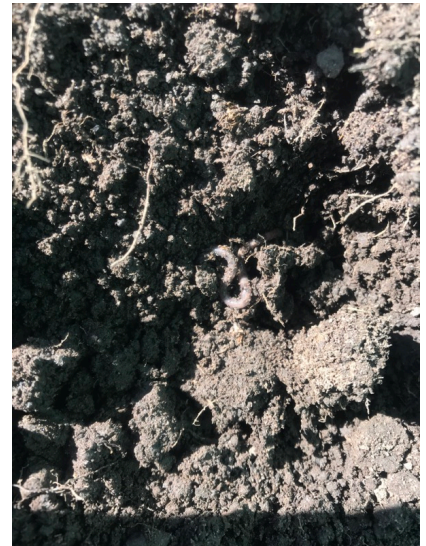
Worms (image 6)
