P&D Monitoring Report Tunnel Hill 2022-23

Tunnel Hill Vineyard

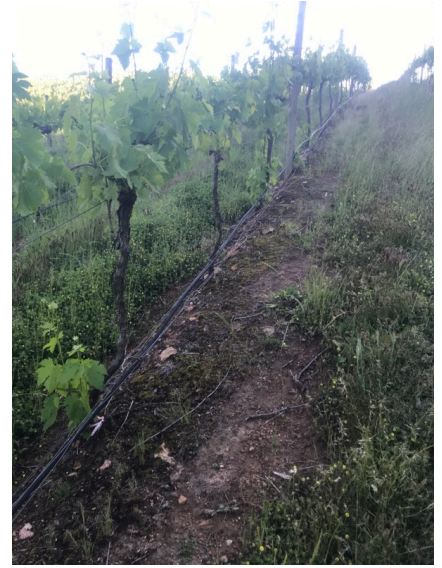
Some big watershoots (image 3).

Fairly clean some weeds returning (image 3), some blackberry (image 6).

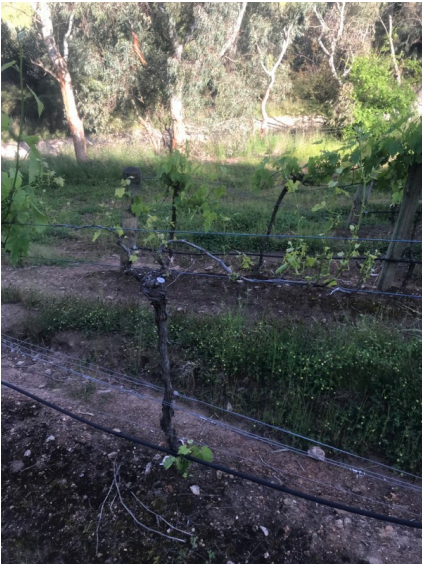
Fairly even, some gaps (image 7), some Eutypa (image 4)

Some Eutypa (image 4)

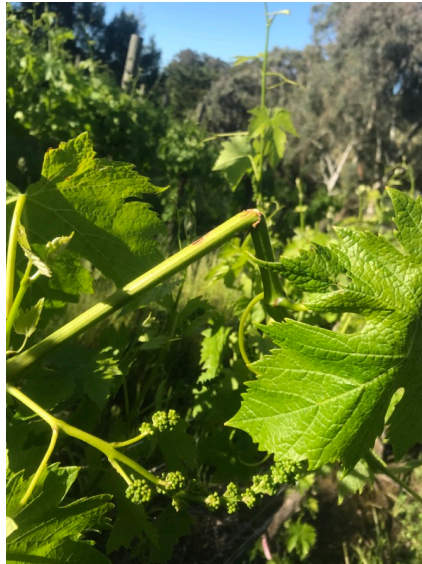
Some wind damage (image 5).

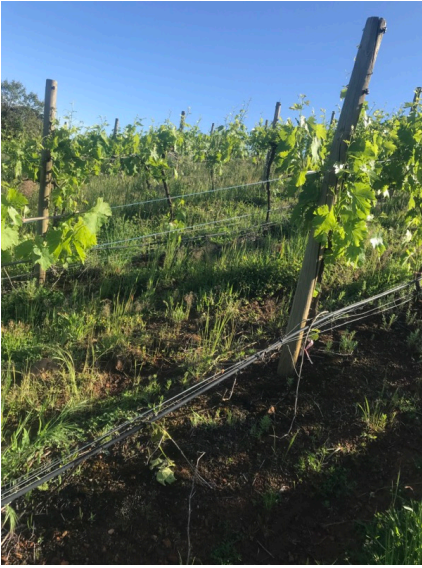
Medium size, light to medium density- some gaps (image 7)

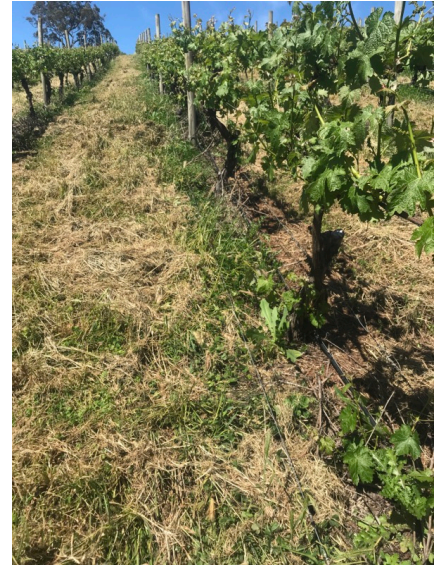
Some watershoots (image 3)

Some weeds returning (image 3), some blackberry (image 5).

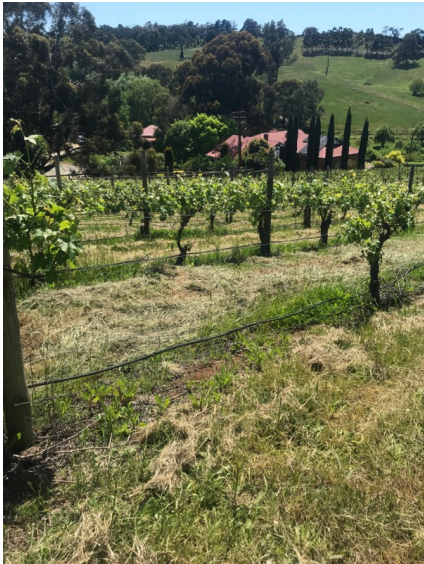
Medium size (image 2), light to medium density - some gaps (image 4).

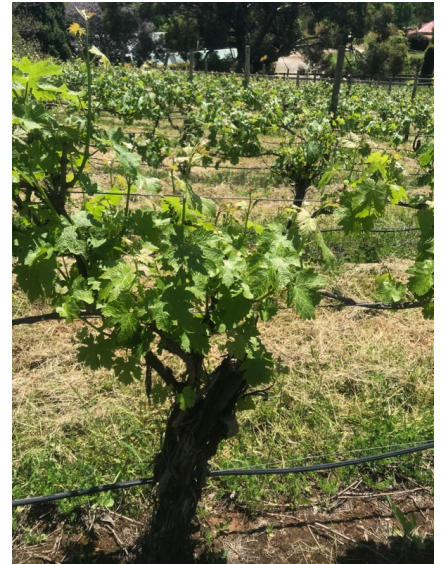
Fairly even shoot growth (image 1), / some dense crowns (image 6).

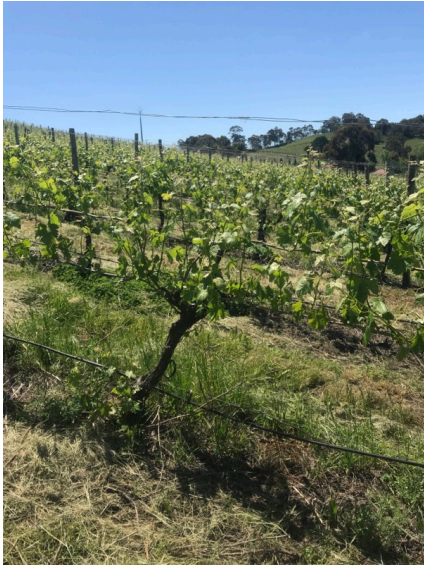
Some uneven shoot growth (image 1), some blind budding (image 4), some dense crowns (image 5)

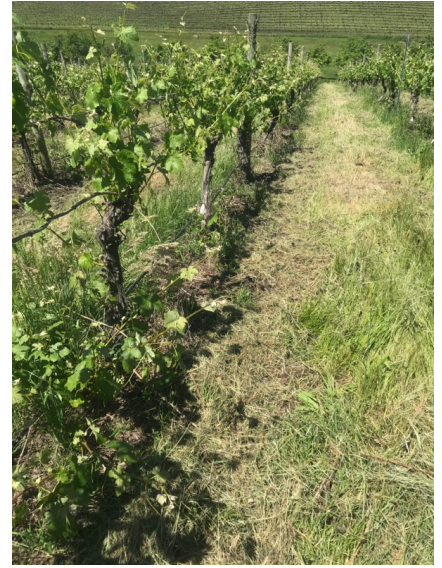
Some weeds returning (image 3), some blackberry (image 7).

Some watershoots (image 3)

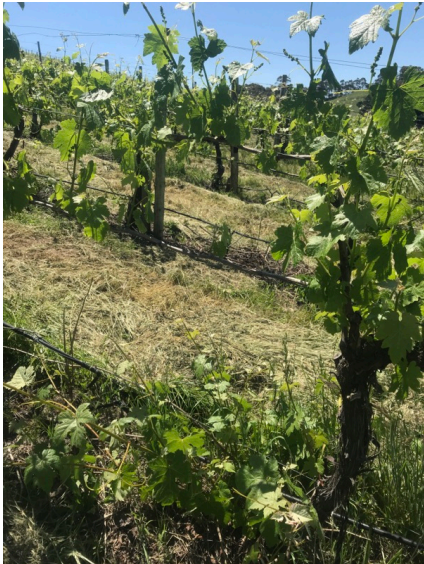
Medium size, light to medium density- some blind budding (image 4)

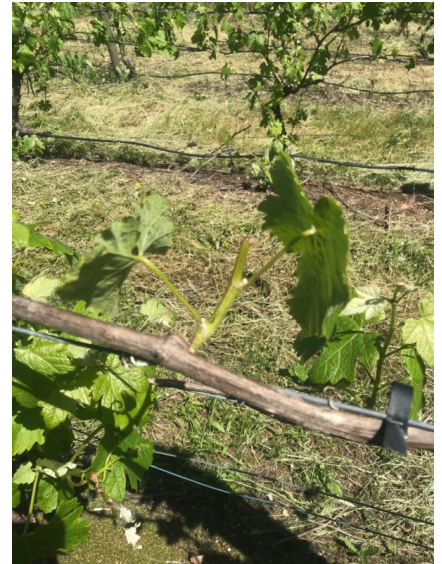
Some kangaroo damage (image 6)

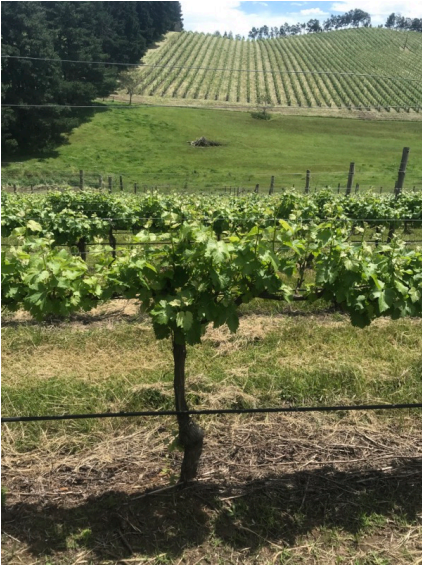
Low to moderate vigour (image 1) dense canopy.

Dense canopy (image 1), some very dense crowns (image 4)

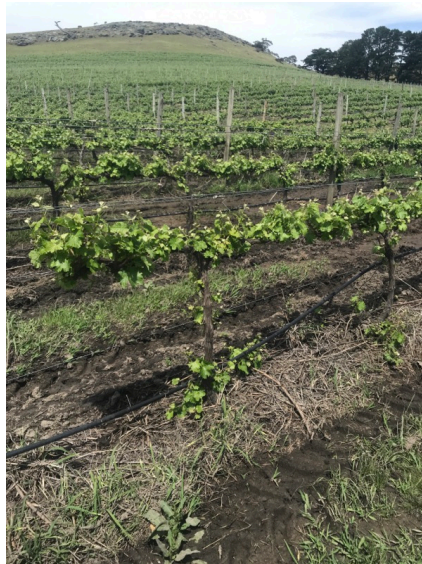
Patches of low vigour swamp area ('wet feet' ? image 5)

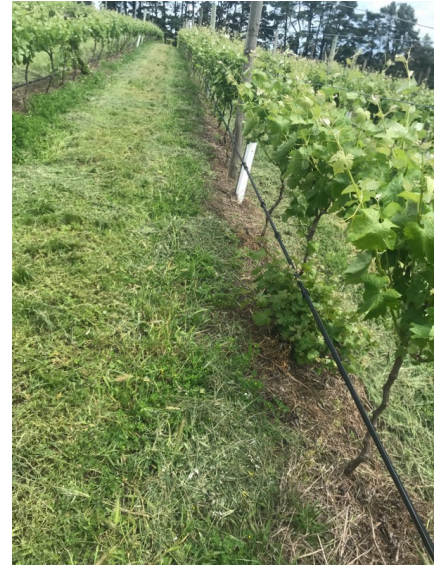
Some watershoots (image 3)

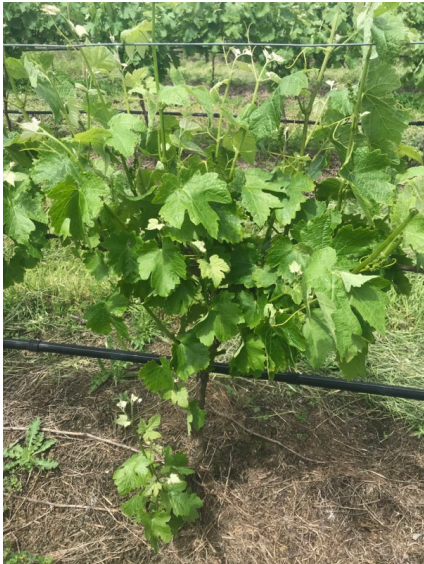
Fairly even shoot growth (image 1), some dense crowns (image 4)

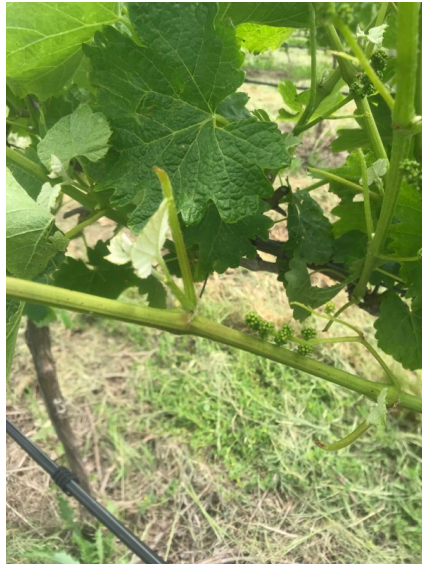
Some kangaroo damage (image 5)

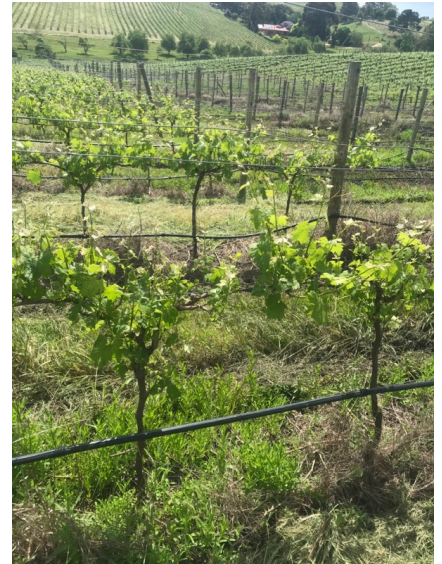
Some low vigour swamp area 'wet feet' (image 6)

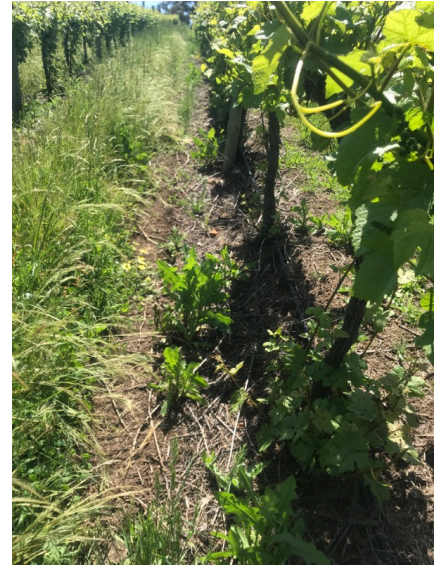
Some heavy watershoot growth (image 3)

Fairly clean, some weeds returning (image 3), some blackberry (image 5).

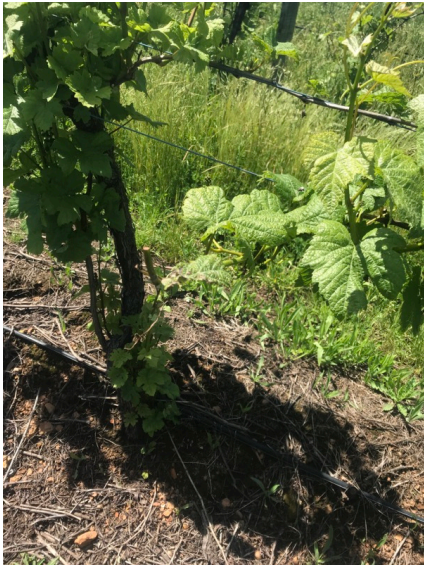
Some kangaroo damage to shoots (image 4)

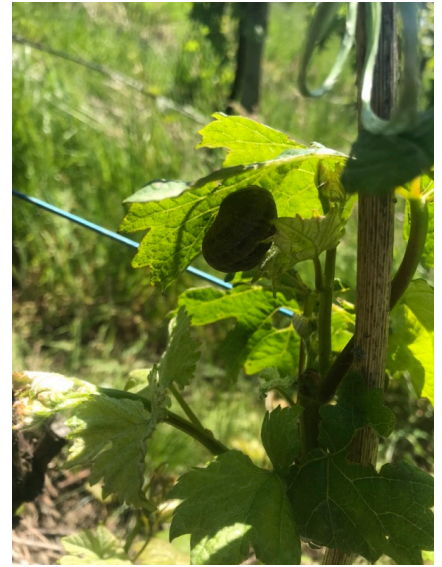
Some snails in the canopy (image 6)-not many (dead snails image 7).

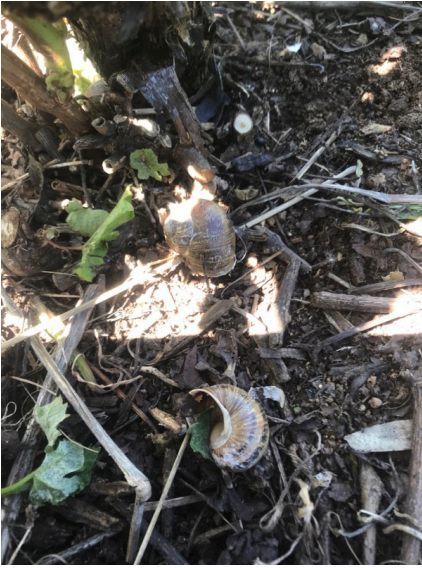
Generally good even shoot growth with medium size inflorescence. With persistent wet conditions there have been Downy Mildew alerts and some leaves have been collected for testing. There are some snails in the Pinot block but baiting has been effective- a lot dead, not many in the canopy and on trunks.

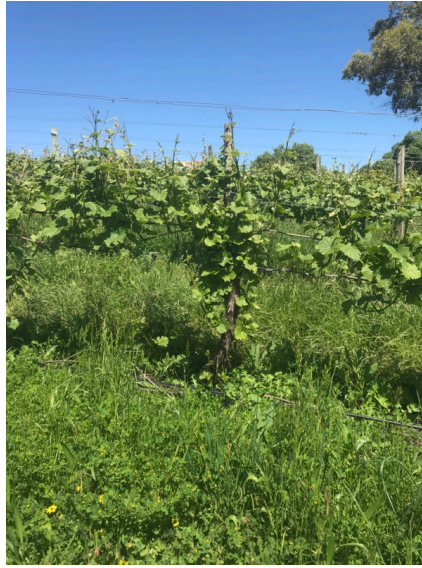
Fairly even, some dense crowns (image 8)
