# Tunnel Hill Vineyard

## P&D Monitoring Report 2020-21

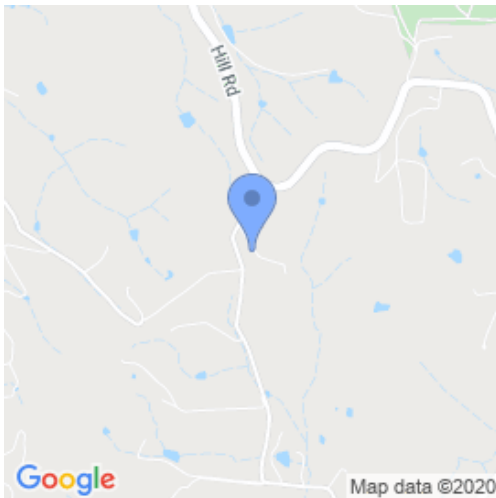
### Block 2 Cabernet Sauvignon

Broken posts removed but not replaced, strainer needs replacing

Foliage wires have been repaired

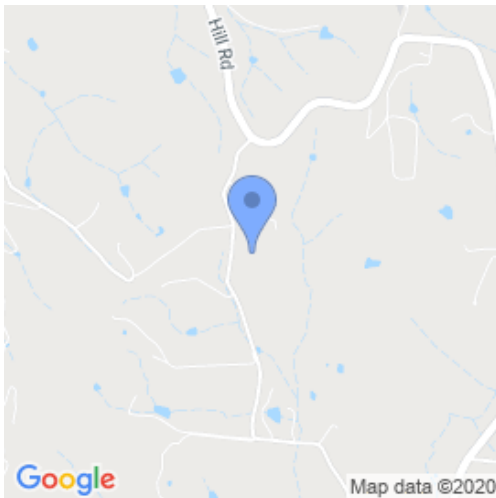
### Block 4a Cabernet Sauvignon

<b>Crown Density (thinning requirements)</b>	<b>Mites</b>	Broken posts removed but not replaced
Not needed	0	<b>Broken Wires</b>
<b>Leaf Colour</b>	<b>Snails</b>	Foliage wires repaired
Deep green	<1	
<b>Canopy Lifting</b>	<b>Scale (adults)</b>	
Lift wires required	<1	
<b>Leaf Loss (shading or stress)</b>

No	Scale (eggs)
Watershoot Growth	0
No	Scale (crawlers)
Fruit / Inflorescence Density, Overcropping	0
No	LBAM (webbing / moths / eggs / caterpillars)
Inflorescence / Bunch Condition & Size	None seen
Good , average size	Weevils
Frost damage	0
No	Eutypa
Cold damage	0
No	Nutrient Deficiency / Toxicity
	Canopy looks healthy
